LABORATORY EVALUATION OF A SHIPBOARD MULTIFUNCTIONAL WASTE INCI--ETC(U)
OCT 79 F CROWSON, J A BYRNE, W W JONES

NSWC/TR-79-264

4. TITLE (and Subtitle) LABORATORY EVALUATION OF A SHIPBOARD MULTIFUNCTIONAL WASTE INCINERATOR (MFI). PHASE II.	5. TYPE OF REPORT & PERIOD COVERED Final rept.	6. PERFORMING ORG. REPORT NUMBER

7. AUTHOR(s) F. J. Crowson J. A. Byrne W. W. Jones	8. CONTRACT OR GRANT NUMBER(s)	
9. PERFORMING ORGANIZATION NAME AND ADDRESS Naval Surface Weapons Center (G51) Dahlgren Virginia 22448	10. PROGRAM ELEMENT, PROJECT, TASK AREA & WORK UNIT NUMBERS NIF

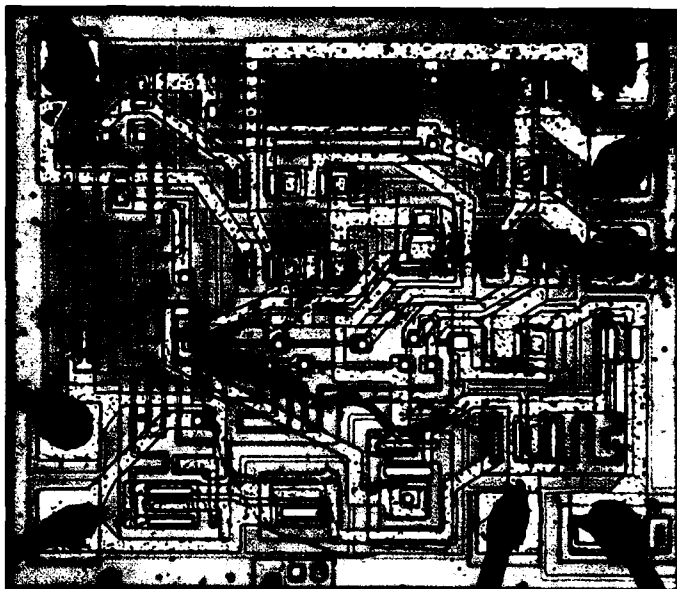
appeared attributable to loss or lack of lubrication. Failure could have been prevented by ensuring adequately high-temperature grease was used for lubrication. Additionally, failure rate can be extended through specification of precision tolerances on bearing construction. The failure of the integrated circuit within the temperature controller appeared to occur from defective construction of the chip circuitry. Figure 5 shows the damage to the chip circuitry at failure. Also, copious debris was observed upon decapsulation of the integrated circuit. This material was present as a result of the fabrication process and could have been prevented by proper quality control by the manufacturer. It is quite possible that this debris aligned itself between two potentials and formed a bridge for an electrical short circuit. This type of malfunction is considered a true failure of the device and can be accommodated most easily by replacement with a spare temperature controller.

Figure 5. Integrated Circuit Failure on MFI-II Temperature Controller
